Michael J. Ellis Seawall Repairs

Stakeholder Update Meeting

Condition Assessment and Inspection Report by Lloyd Engineering, Inc. (Terracon, Inc.)

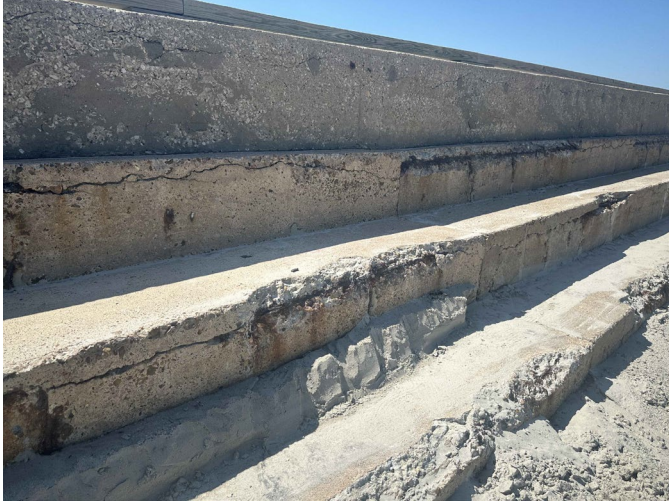
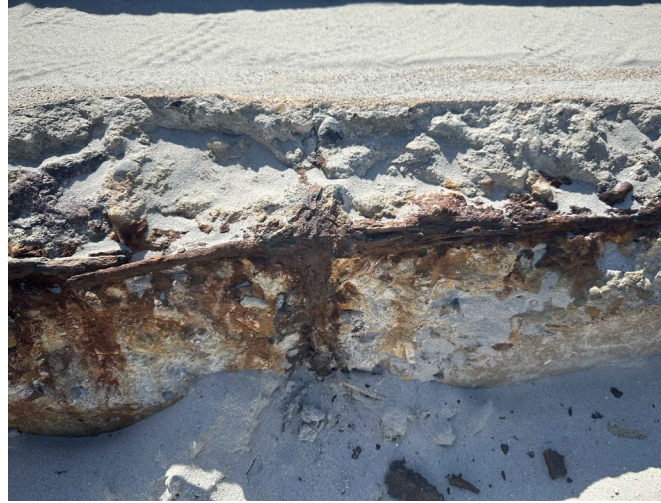
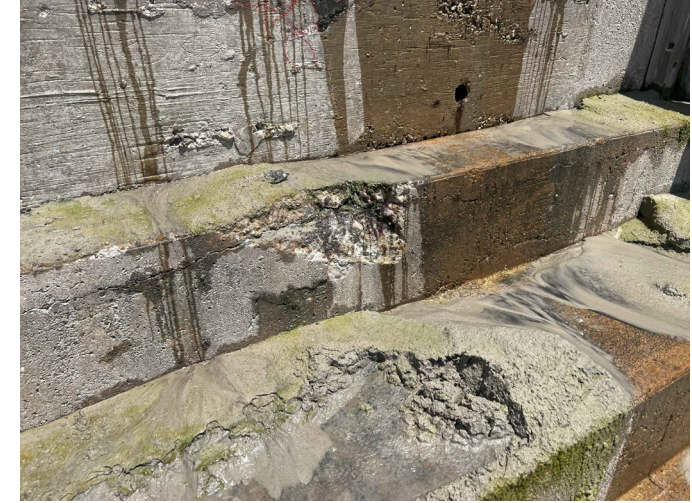
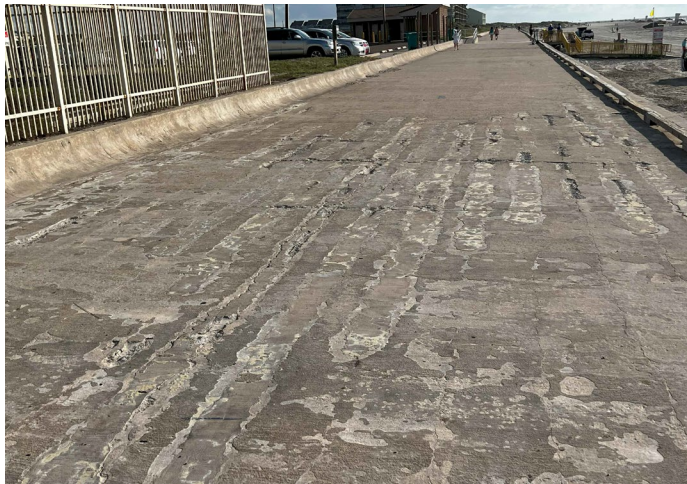
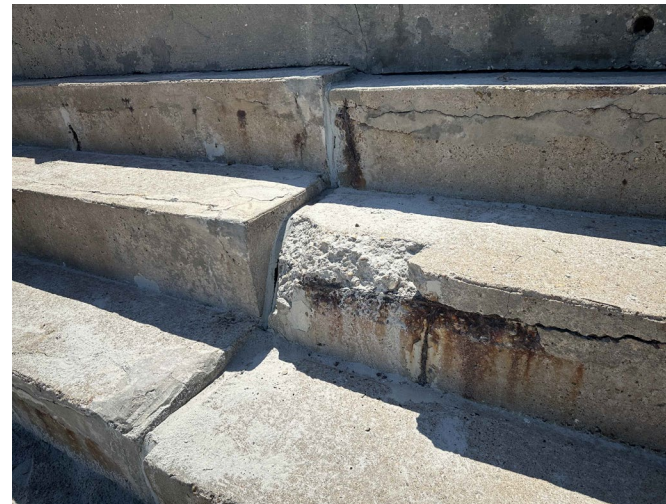
- Poor condition w/ widespread moderate to severe spalling
- Areas of corroded steel reinforcement
- Ground Penetrating Radar: Indicated that there were no apparent voids
- Cores: Current concrete strength – 6,800 psi
- As the concrete is exposed to the corrosive, marine environment, the concrete is experiencing significant deterioration

- Spall repairs – cleaning (water blasting), chipping away of loose debris
- Dowel into existing seawall, anchoring
- 6" concrete topping/cap (structural analysis was completed for additional dead load) to the top of the bottom step
- Protective epoxy coating

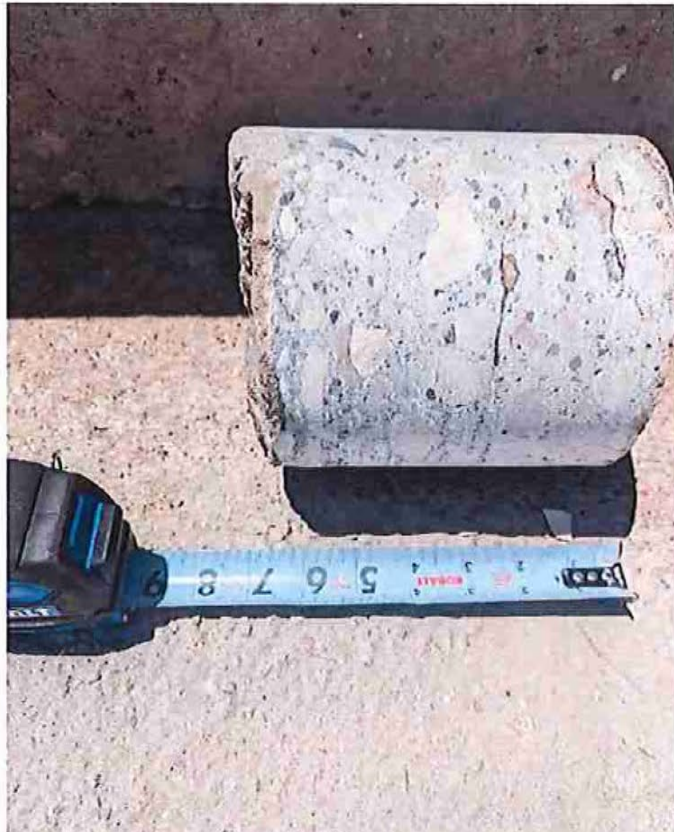
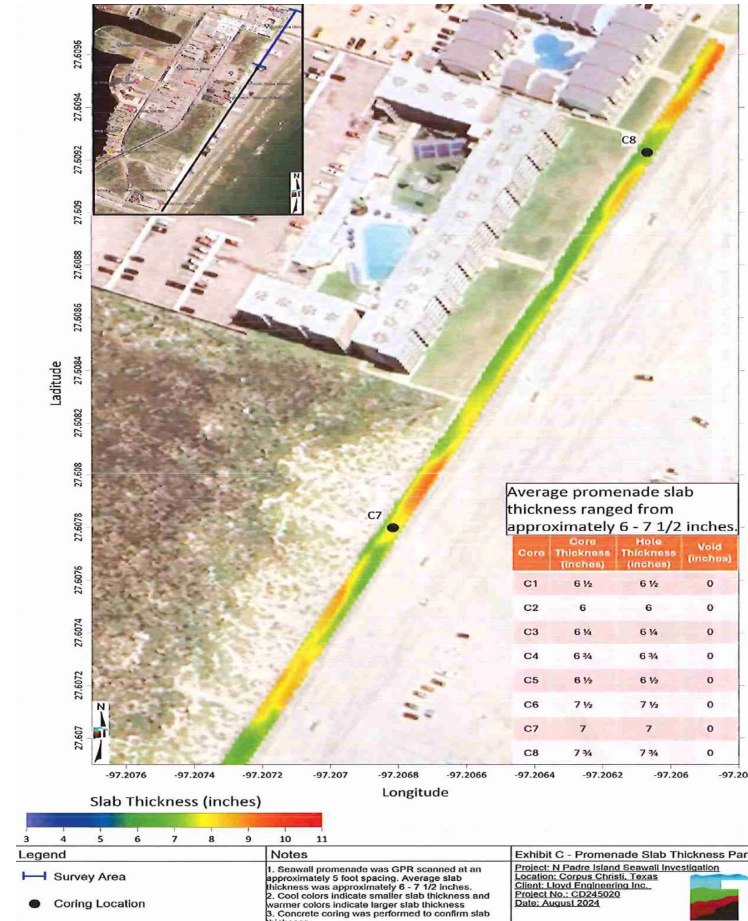
Page from Terracon's investigation Report – Ground Penetrating Radar (Estimated Slab Thickness)

Promenade Deck: Average of 6"-7" Thick

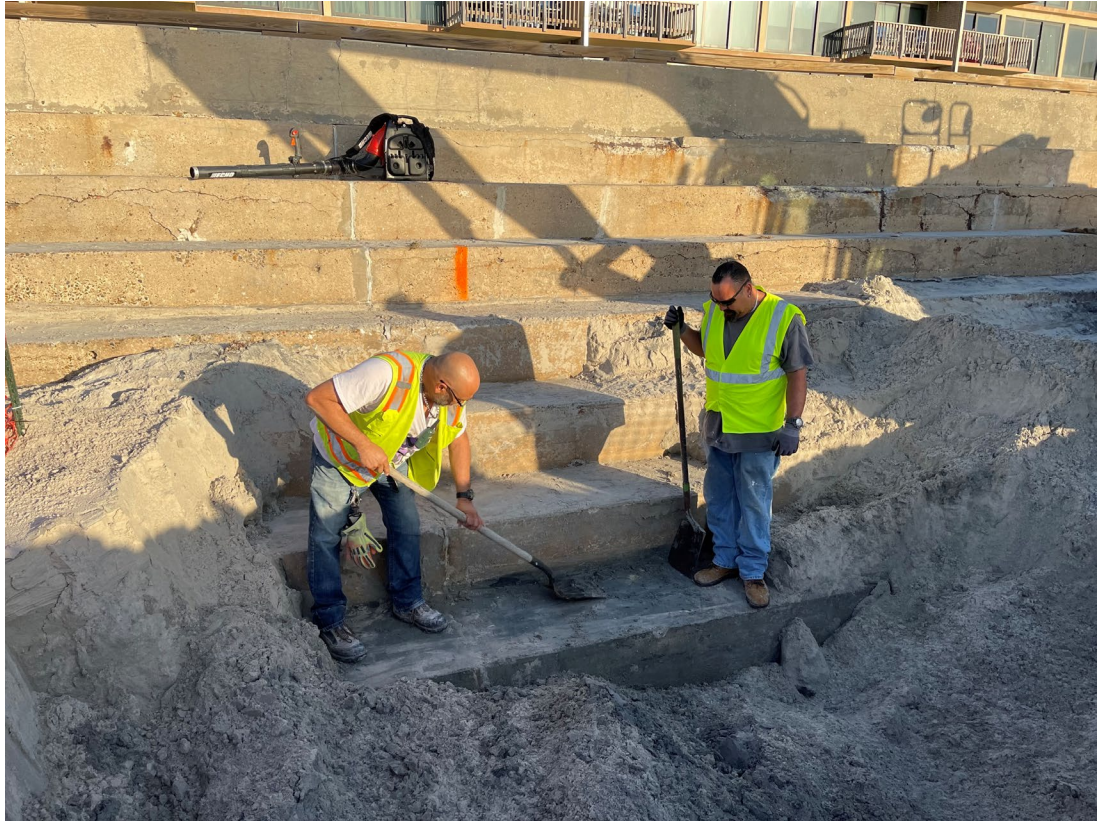
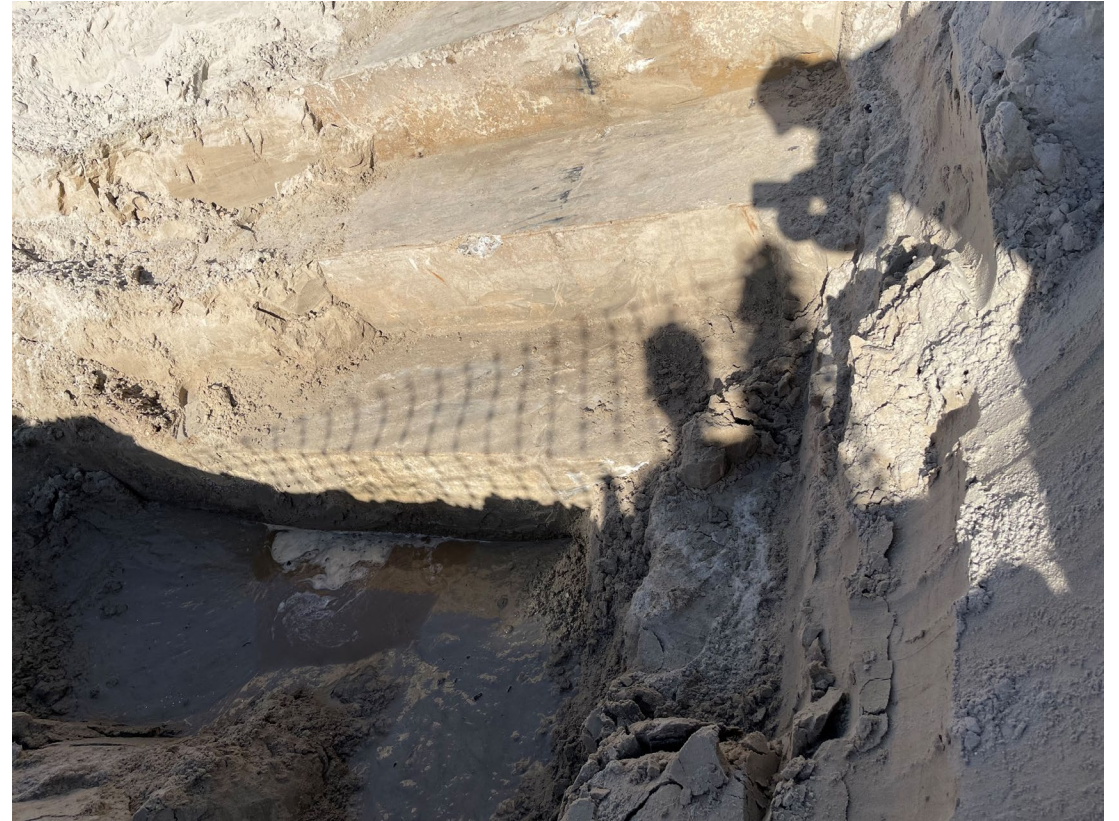
Further Investigation of steps below grade indicated the steps below grade were in a little better condition than those above grade and there was no rip-rap as shown on original drawings
